# Manhole Inspection Summary

Manhole # S41AA\_023MH

Insp Date: **1/30/09 12:19 PM**

**Location** Address: **1300 e monument st**

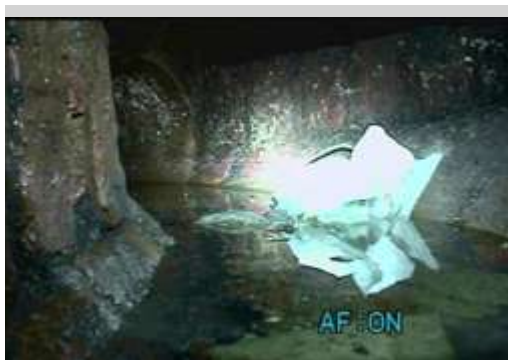
Miscellaneous

channel debris

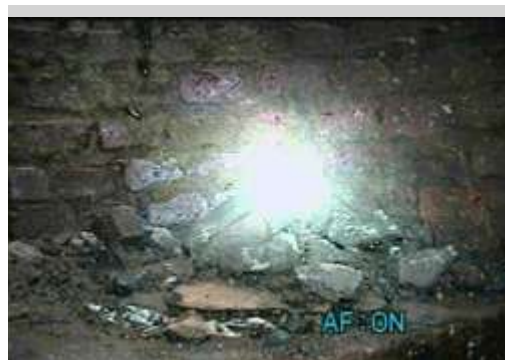
Miscellaneous

bench debris

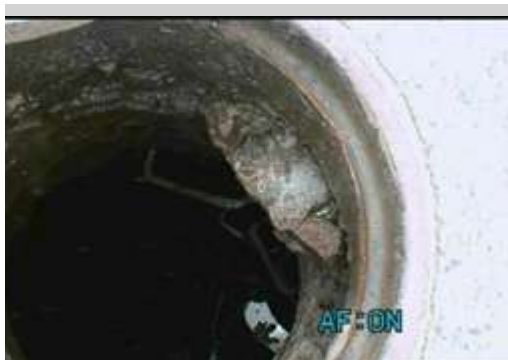
Defect 3

Offset: **4** (in.)

frame offset 4 inches

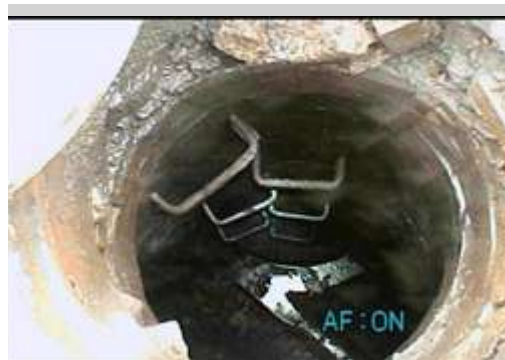
Defect 2

Count: **6** Missing: **0** ☒ **Corroded**

steps corroded

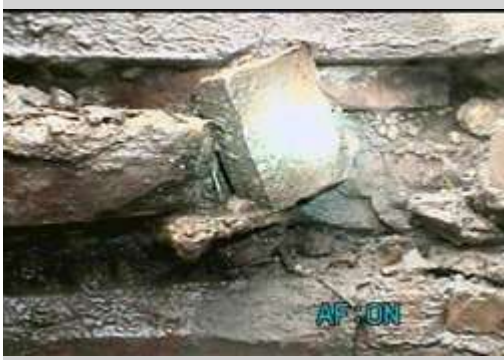
### Defect 1

Condition: ☐ Sound ☐ Cracked ☐ Root Intrusion ☒ **Loose Brick** ☒ **Deteriorated**

chimney loose bricks deteriorated at  
frame joint
